## THESIS

FATIGUE CRACK GROWTH RATES OF HIGH-  
MAGNESIUM ALUMINUM-MAGNESIUM ALLOYS AS  
INFLUENCED BY SOLUTION TREATMENT TIME  
AND ALLOY CONTENT

Kurt D. Oberhofer

June 1983

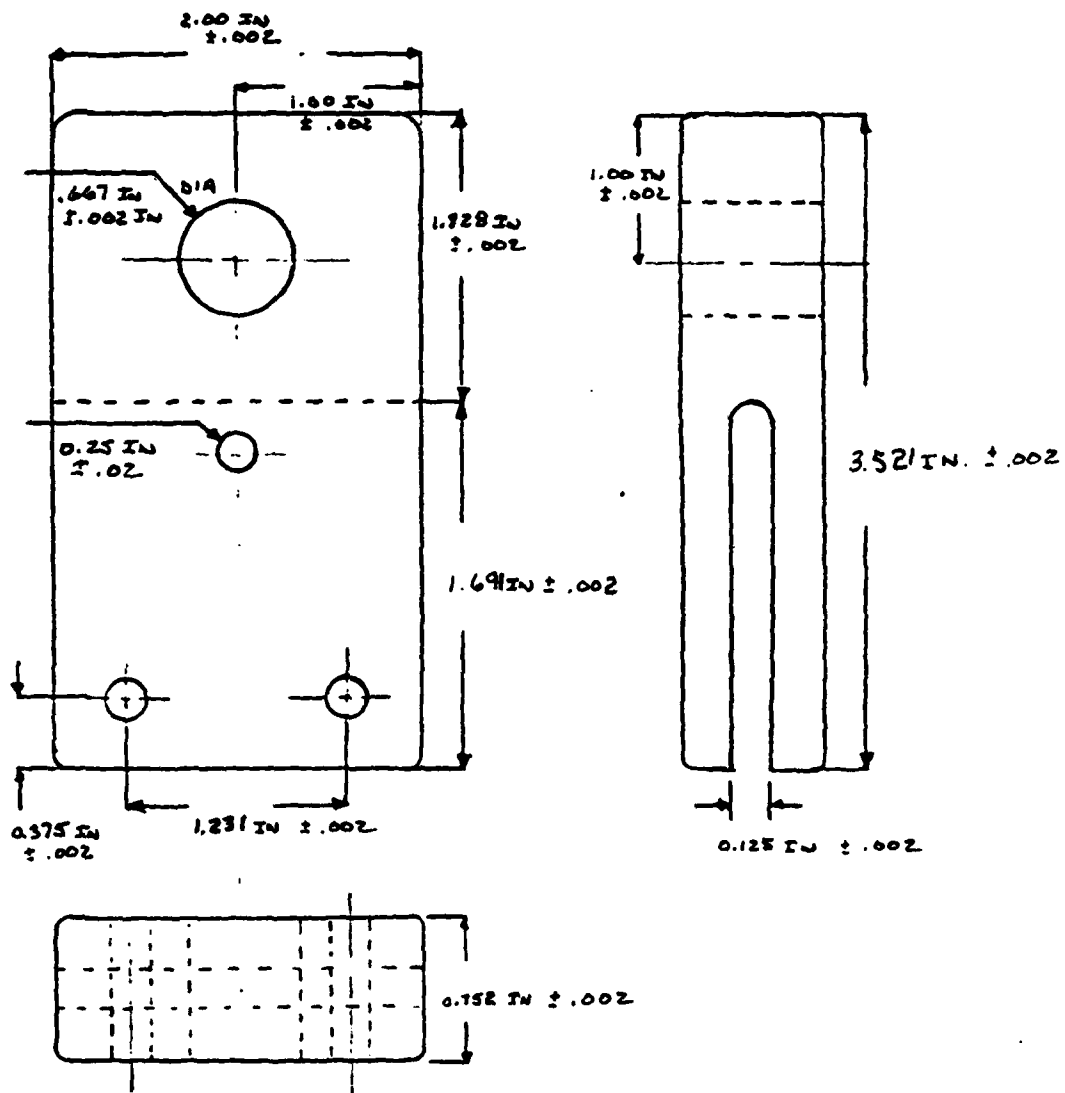
FIGURE 2.1 . DIAGRAM OF CLEVIS ASSEMBLY FABRICATED FROM 4140 STEEL

The clevis assembly was designed to pull a two-pin tensile specimen as outlined in Reference 4. Due to premature failure of the test specimen in the pin region, the test specimens had to be redesigned. This also required a clevis design different from that required in Reference 4. The material selected for the clevis assembly was 4140 steel. The heat treatment procedure was in accordance with Reference 6: austentize at  $871^{\circ}\text{C}$  for one hour, oil quench and temper at  $482^{\circ}\text{C}$  for one hour. Both pieces were wrapped in nickel foil with titanium chips added to act as an oxygen getter. The clevis assembly was designed initially in accordance with Reference 8, but premature failure of the sample in the clevis region required re-design of the assembly as shown in Figure 2.1. The pins that were initially used in the clevis assembly were replaced with stainless steel bolts. By using the bolts in the clevis assembly it was possible to increase the normal force on the specimen surface, which distributed the load more uniformly, and the problem with premature failure at the clevis region was solved with no distortion of the bolt holes in the specimen during the fatigue test.

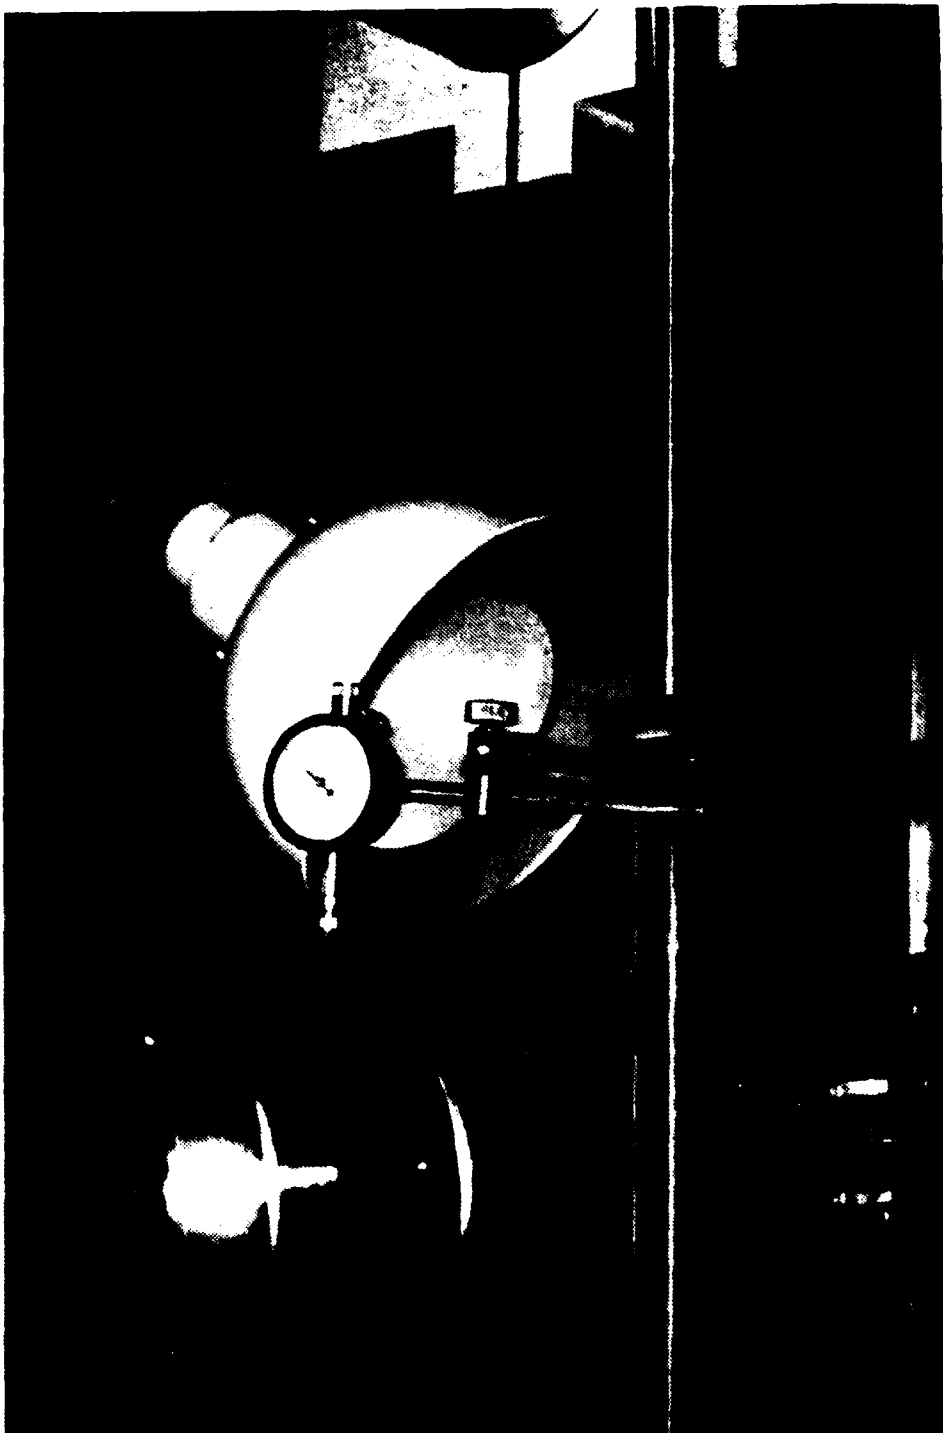
FIGURE 2.2 THE ALIGNMENT APPARATUS AS MOUNTED ON THE MTS MACHINE SHOWING THE DIAL INDICATOR AND LOAD CELL, DURING CENTERING OF LOAD CELL. THE GRIPS AND HYDRAULIC RAM ARE BELOW THE BAR.

An alignment device was designed and fabricated to assure accurate alignment of the testing machine and specimen axis (Figure 2.2). The reference bar was held in place by two brackets which were machined from aluminum. Use of aluminum prevented damage to the load frame assembly when the alignment fixture was tightly secured (Figure 2.3). Both ends and the center of the reference bar were machined flat so that when the assembly was rigidly mounted all surfaces remained square. The center of the reference bar was calibrated in 3.175 mm (0.125 in) increments to facilitate the alignment procedure. A dial indicator was mounted on the bar and positioned so that full movement of the load cell could be measured. The load cell was moved horizontally to full left and right deflections in the crosshead and the readings were taken from the dial indicator. These readings were then added together and their sum halved to give the mean load cell position in the crosshead. This procedure was repeated several more times to verify the load cell was completely centered. To further verify the results of the dial indicator readings a machinist square was positioned on the center of the reference bar and a set of measurements was taken. This procedure insured that the material testing machine load cell was accurately aligned.

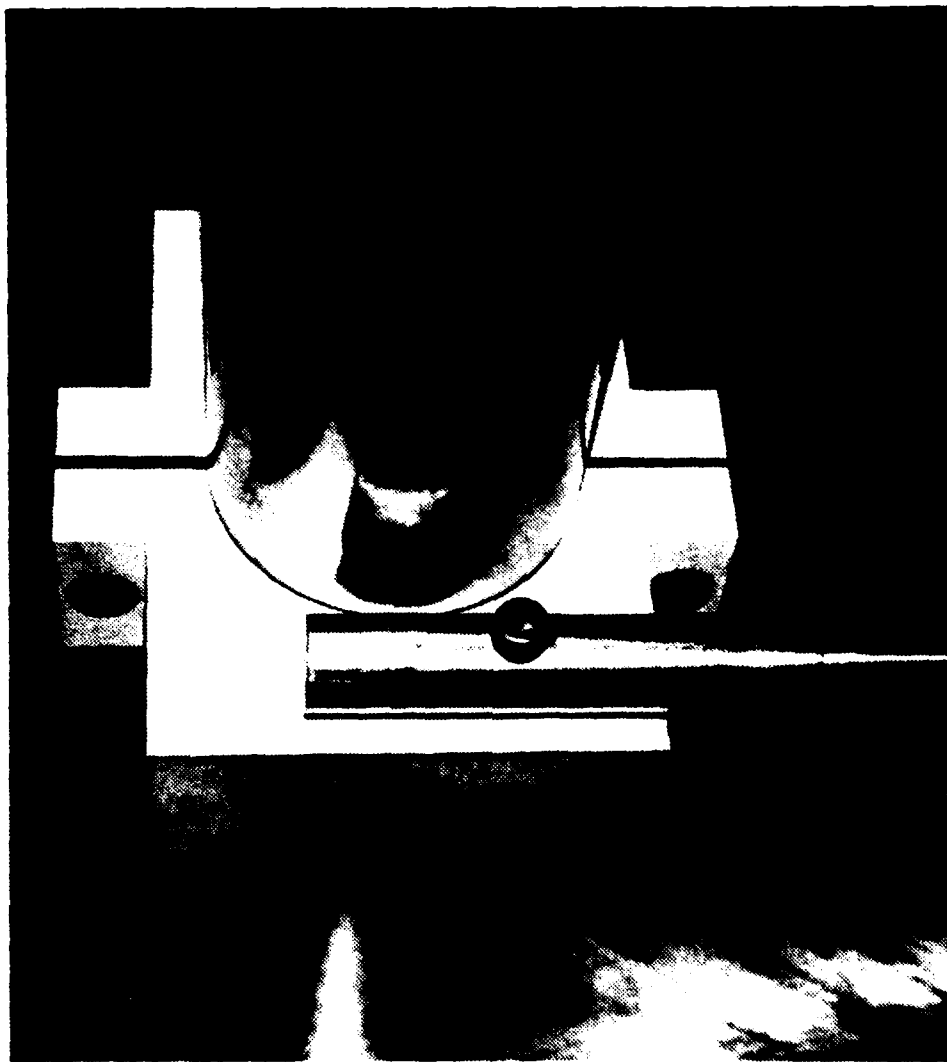
FIGURE 2.3 THE ALIGNMENT BAR CLAMP AS MOUNTED ON THE LEFT  
SIDE OF THE LOAD FRAME ASSEMBLY CONSTRUCTED OF ALUMINUM  
AND SUPPORTING STEEL ALIGNMENT BAR

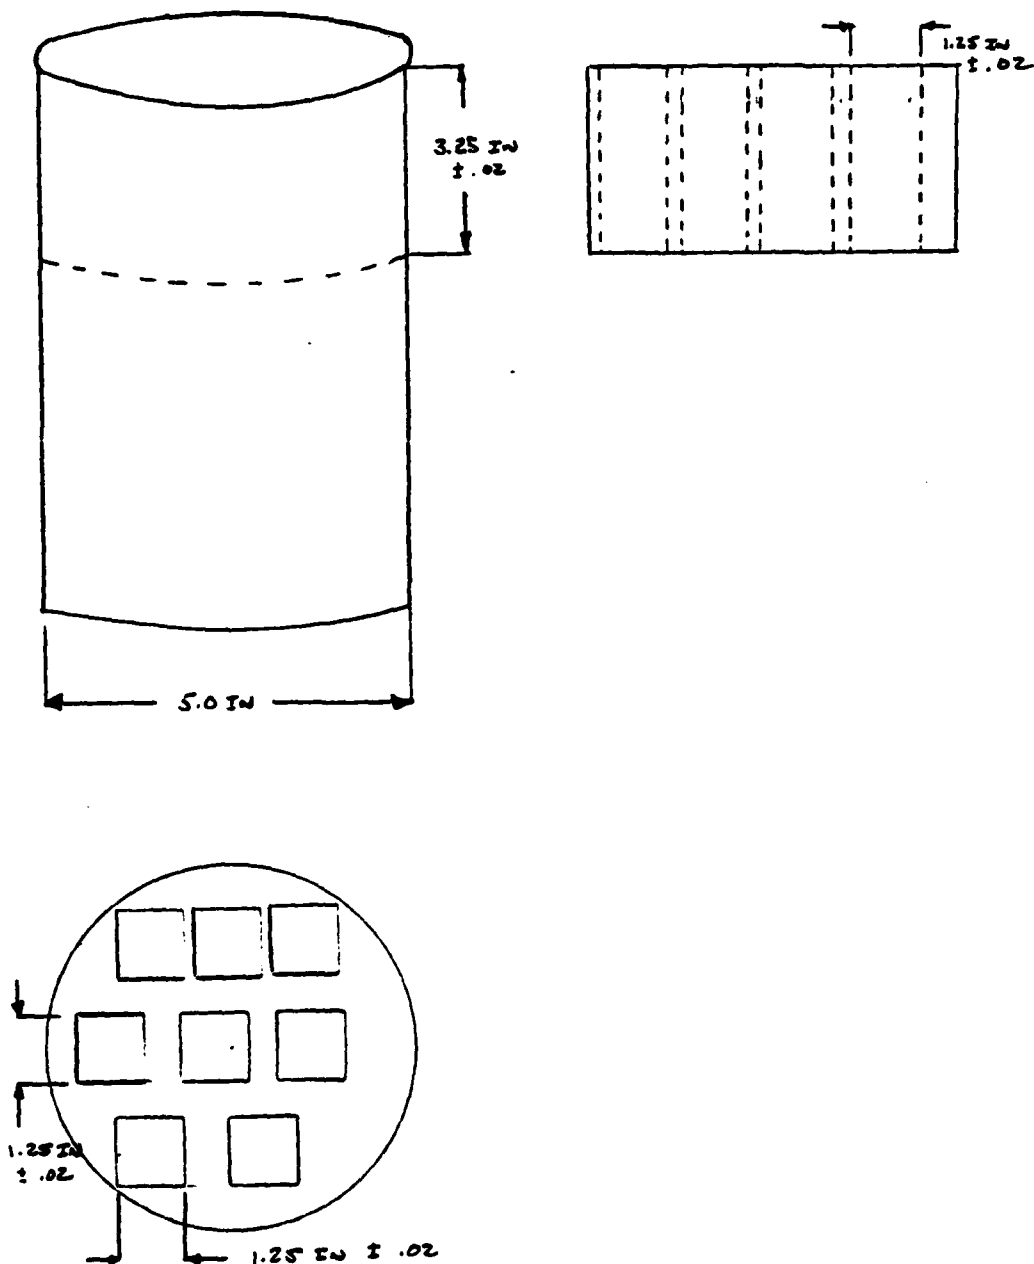
Figure 2.4 DIAGRAM SHOWING THE SECTIONING OF THE AS-CAST INGOT TO OBTAIN BILLETS FOR THERMO-MECHANICAL PROCESSING.

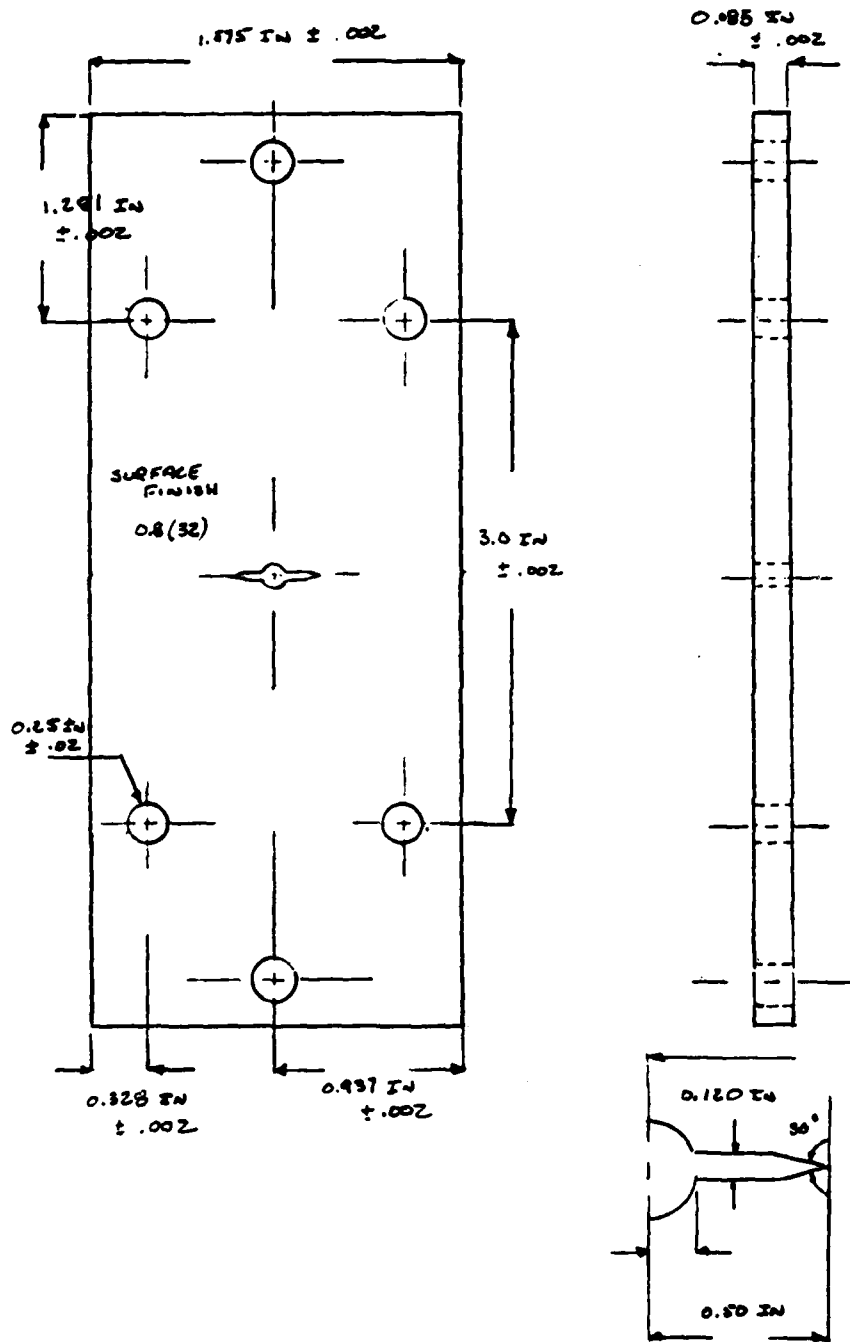
Figure 2.9 SCHEMATIC DIAGRAM OF THE FINAL DESIGN OF THE CENTER-CRACK TENSION TEST SPECIMEN USED FOR FATIGUE CRACK GROWTH MEASUREMENT.

Following rolling, the billets (Figure 2.7) were machined in accordance with Reference 4. Premature cracking in the area of the pinhole of the sample was noted in crack growth measurements and this required a design modification (Figure 2.8). The final design for the crack initiator notch was chosen after several crack growth measurements were performed using the 7075-T6 alloy test material. This consisted of drilling a 4.98 mm (0.196 in) hole in the center of the specimen and then making a saw cut out from both sides of the hole. The sawcuts were required to be accurate to ensure that they were square with the sample ends. This ensured that the load distribution was symmetrical with respect to the specimen notch. The details of the crack initiator notch geometry are shown in Figure 2.9; also of note is the 30 degree crack angle at the notch tip, also shown in Figure 2.9.

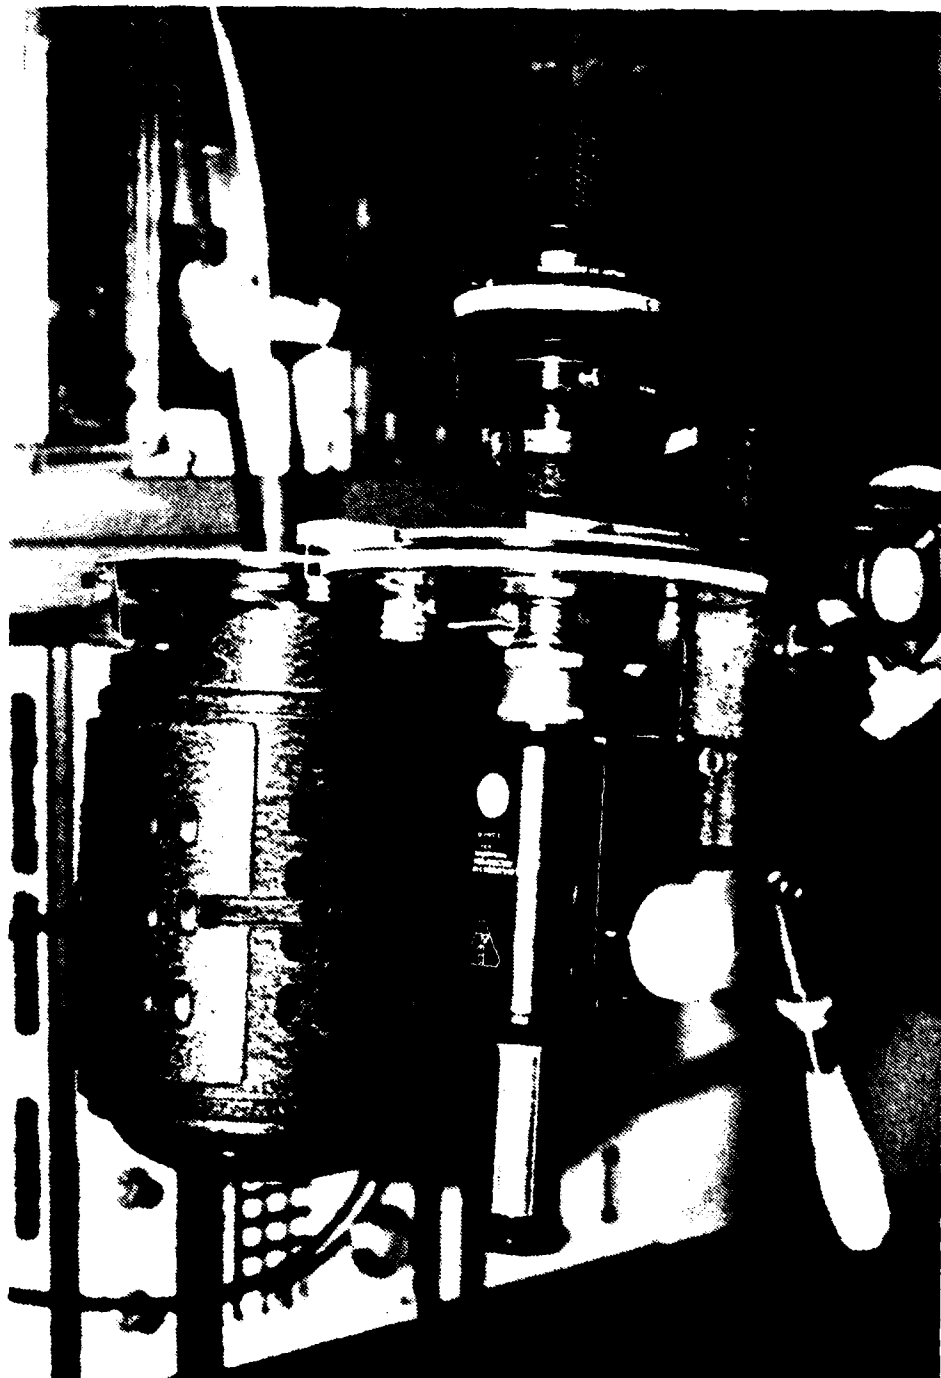
FIGURE 3.2 OPTICAL DEVICE USED TO MEASURE CRACK LENGTH, A BAUSCH & LOMB  
22.7 MM, 6X TELESCOPE IN CONJUNCTION WITH A HEON 86 MM 300X LENS

A haversine waveform was selected from the digital function generator of the MTS machine. This, with the fifty pound pre-load ensured that a tensile load was applied to the specimen at all times. Fatigue crack length measurements were made as a function of elapsed cycles by means of an optical device shown in Figure 3.2. This was used following the procedures as outlined in Reference 7. The device consists of a Bausch and Lomb 22.7 mm, 6X telescope in conjunction with a Nikon 86 mm zoom lens. The surface of the specimen was sprayed with steel blue layout fluid to make the crack more visible. Reference marks were applied in .381 mm (0.015 in) divisions from the notch tip to the edge of the sample. By using a stationary optical device and reference marks as opposed to a

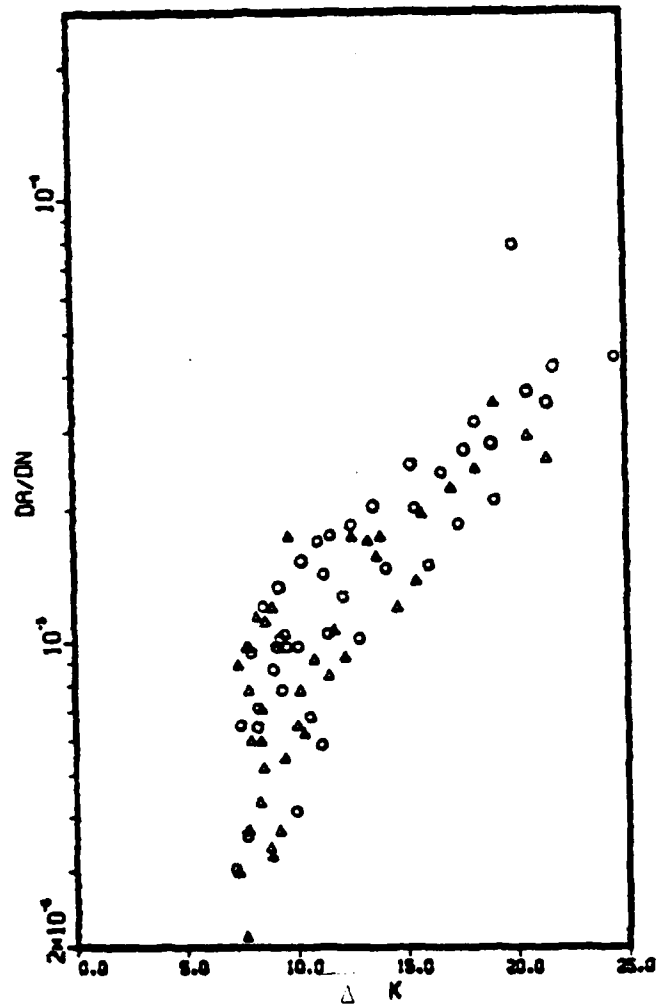
FIGURE 4.1 FATIGUE CRACK PROPAGATION DATA FOR 7075-T6 ALLOY

The 7075-T6 alloy was chosen for initial testing due to the availability of well documented data for comparison and validation of test procedures, and also the local availability of the material in large quantities. The crack growth data obtained for this material as shown in Figure 4.1,  $\Delta k$  and follows closely the data reported in Reference 9.

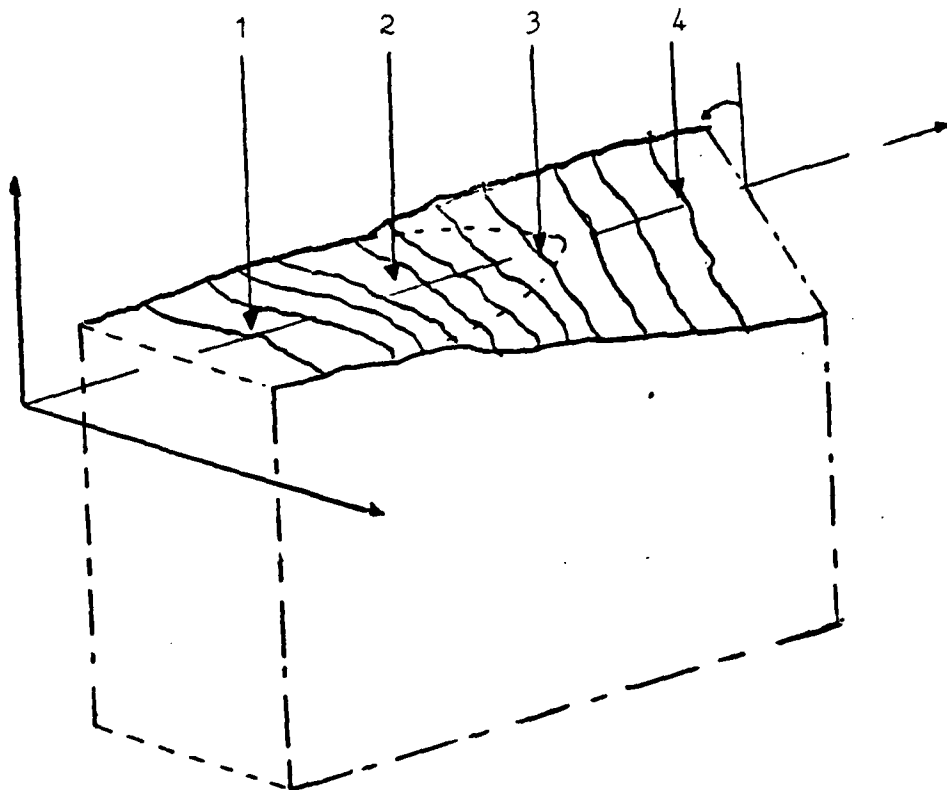
FIGURE 4.2 A SCHEMATIC SHOWING SCANNING ELECTRON MICROGRAPH LOCATIONS ON THE FATIGUE CRACK SURFACE FOR THE 7075-T6 AND THE MANGANESE, AND COPPER CONTAINING ALLOYS

Fatigue crack surfaces were examined by scanning electron microscopy (SEM). Fractograph locations for all SEM work are shown in Figure 4.2 and fractographs of the 7075-T6 alloy are shown in Figure 4.3. Observed in the fractographs are small "dimples", microvoids and crack

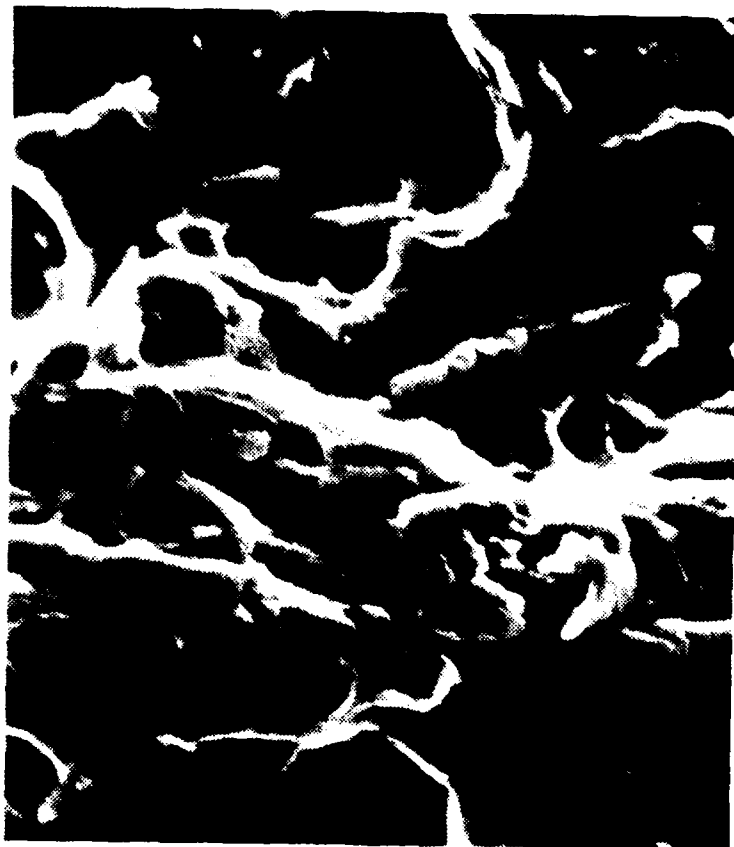
FIGURE 4.3    FRACTOGRAPH OF THE FATIGUE CRACK GROWTH SURFACE  
FOR THE 7075-T6 ALLOY

ridges. The appearance of the crack surface follows very closely that described in Reference 10 for 7075-T6 and indicates that a uniaxial load was applied to the test specimen. The voids observed were probably nucleated by iron and silicon-rich second phase particles present in the alloy. It has been proposed by Reference 9 that the presence of these compounds in the alloy causes a reduction in fracture toughness.

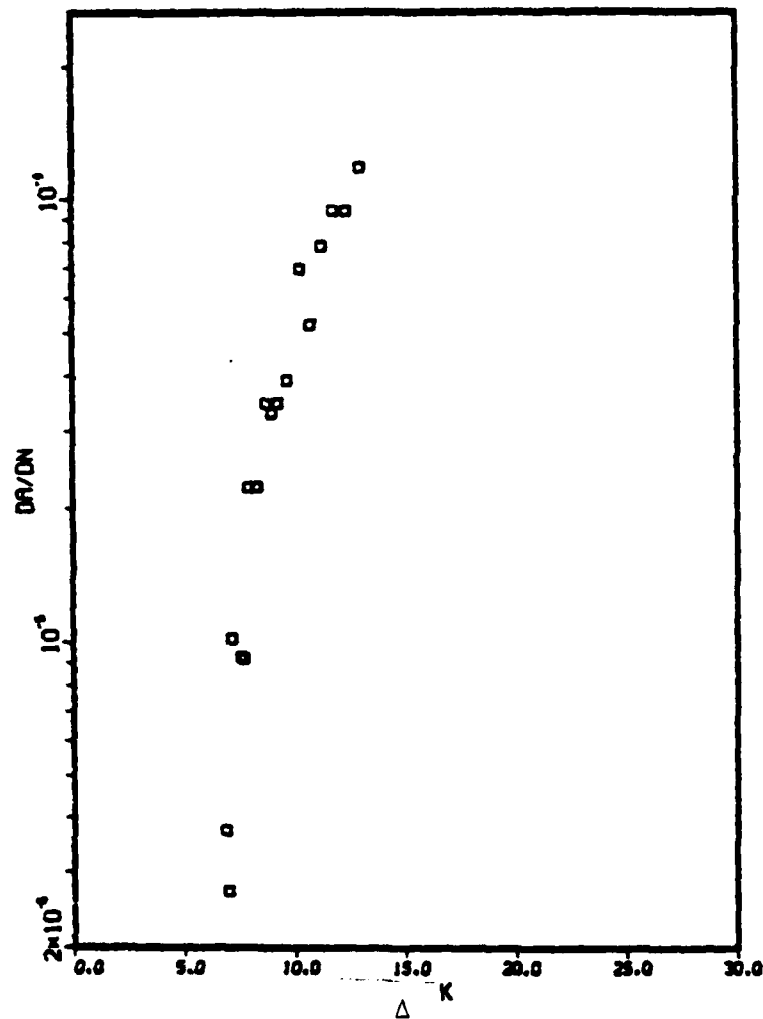
FIGURE 4.4 FATIGUE CRACK PROPAGATION DATA FOR THE Al-10.2  
WT PCT Mg-0.52 WT PCT Mn ALLOY SOLUTION TREATED FOR NINE HOURS

The crack propagation data obtained for the nine hour solution treated Al-10.2 wt pct Mg-0.52 wt pct Mn alloy (Figure 4.4) shows it to be less fatigue crack growth resistant than the 7075-T6 alloy. The alloys appear to have similar threshold values of  $\Delta K$ , about  $7.5 \text{ ksi } \sqrt{\text{in}}$ , below which the crack growth rate decreases rapidly. The twenty-five hour solution treated Al-10.2 wt pct Mg-0.52 wt pct Mn alloy shows an even further degradation in the fatigue crack growth resistance compared to that of the nine hour solution treated alloy as shown in Figure 4.5.

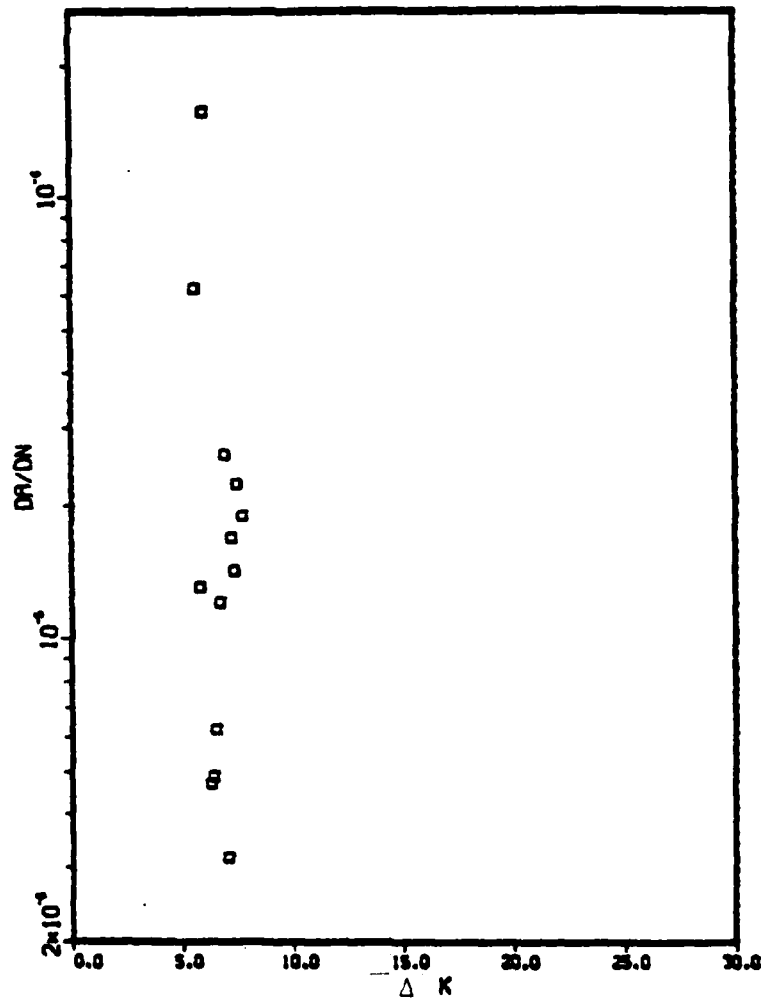
FIGURE 4.5 FATIGUE CRACK PROPAGATION DATA FOR THE Al-10.2  
WT PCT Mg-0.52 WT PCT Mn ALLOY SOLUTION TREATED  
FOR TWENTY-FIVE HOURS.

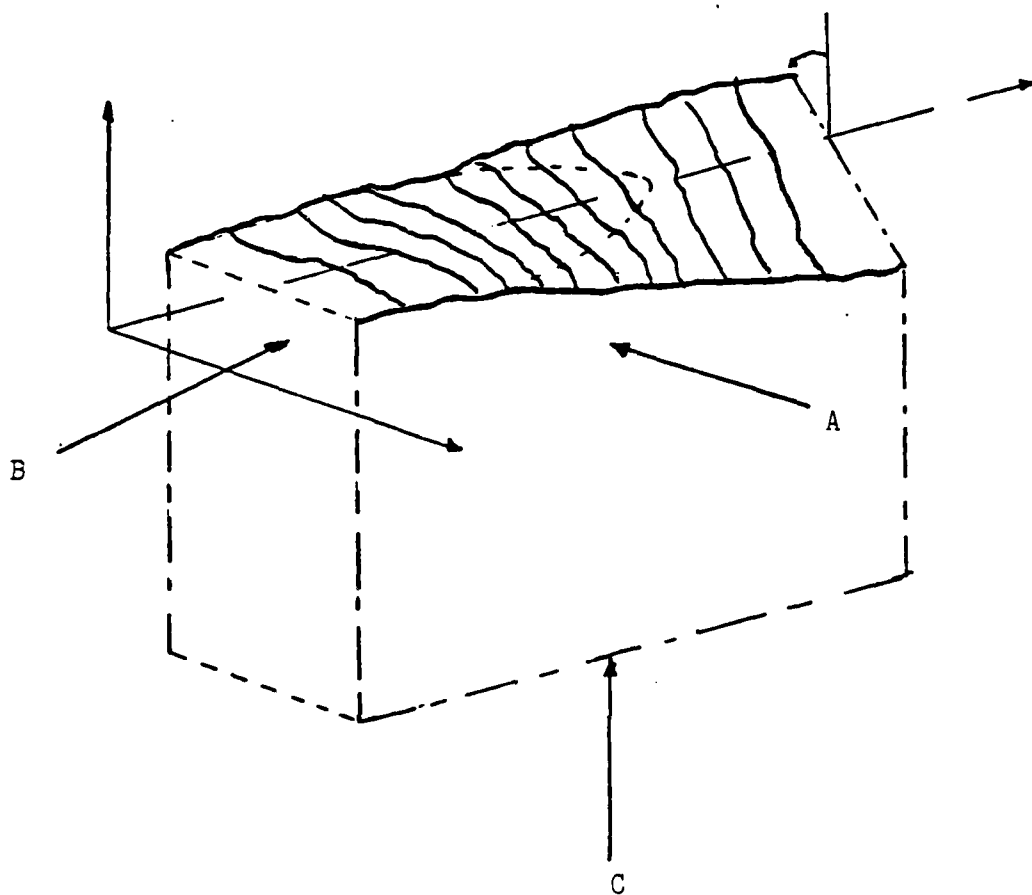
FIGURE 4.10 OPTICAL MICROGRAPH LOCATIONS FOR THE 9 AND 25 HOUR SOLUTION TREATED Mn CONTAINING ALLOYS, AND Cu CONTAINING ALLOYS.

Optical micrographs of the nine hour and twenty-five hour solution treated alloys are shown in Figures 4.8 and 4.9 respectively. The relative locations of the micrographs with respect to the crack surface are shown in Figure 4.10. There is little difference in the micrographs between the two

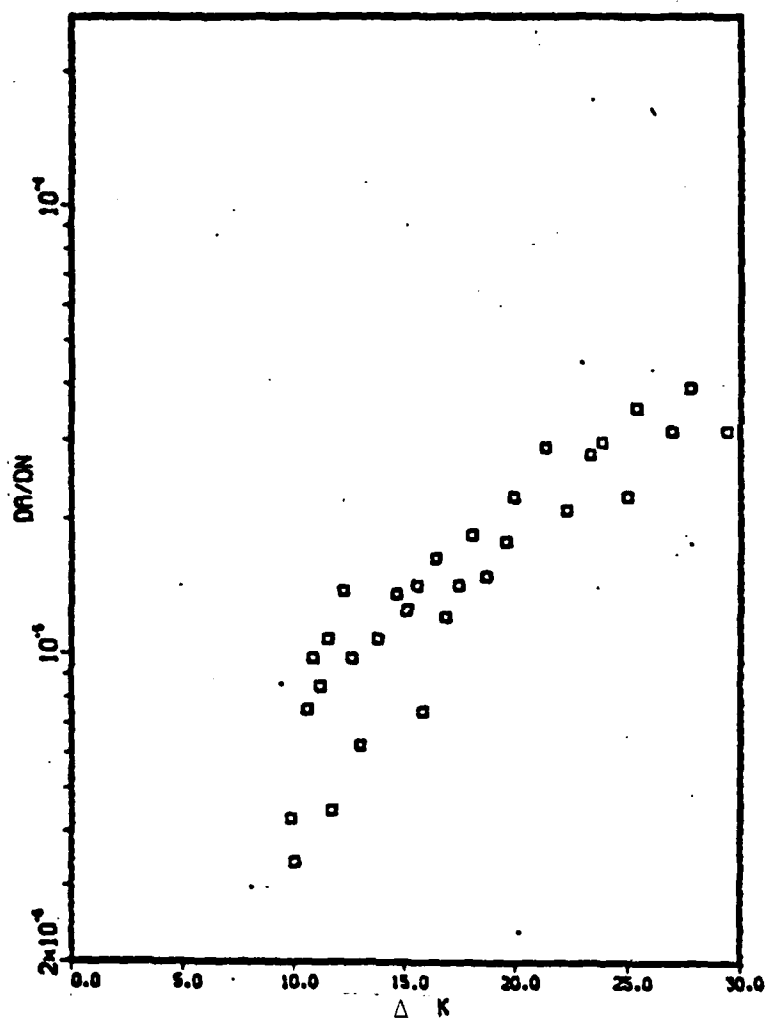
FIGURE 4.11 FATIGUE CRACK GROWTH DATA FOR Al-8.14 WT PCT  
Mg-0.40 WT PCT Cu ALLOY.

Fatigue crack growth data for the Al-8.14 wt pct Mg-0.40 wt pct Cu alloy are presented in Figure 4.11. The data for this alloy indicates a higher threshold stress intensity ( $\Delta = 10 \text{ ksi } \sqrt{\text{in}}$ ) for fatigue crack growth than either the 7075-T6 or Al-10.2 wt pct Mg-0.52 wt pct Mn alloys. At higher stress intensity values, crack growth rates for this alloy are much reduced in comparison to the manganese containing alloy and are also lower than those measured for the 7075-T6 in this research. Crack growth rates were measured at  $\Delta$  values up to  $30 \text{ ksi } \sqrt{\text{in}}$ , where the growth rate measured was approximately  $3 \times 10^{-5} \text{ in/cycle}$ . This reflects a higher degree of toughness in this alloy. It must also be noted, however, that this is the lowest strength material of the three different compositions evaluated in this research and is certainly a factor in the higher apparent toughness of this alloy. At this point, the appropriate strength toughness data has not been obtained to facilitate comparison of these alloys amongst themselves or with conventional alloys.
